**LAKE WATATIC DAM**  
**PHASE I**  
INSPECTION / EVALUATION REPORT

Dam Name: Lake Watatic Dam  
NID#: MA00004  
Owner: Town of Ashburnham  
Town: Ashburnham, Massachusetts  
Consultant: Tighe & Bond, Inc.  
Date of Inspection: April 16, 2024

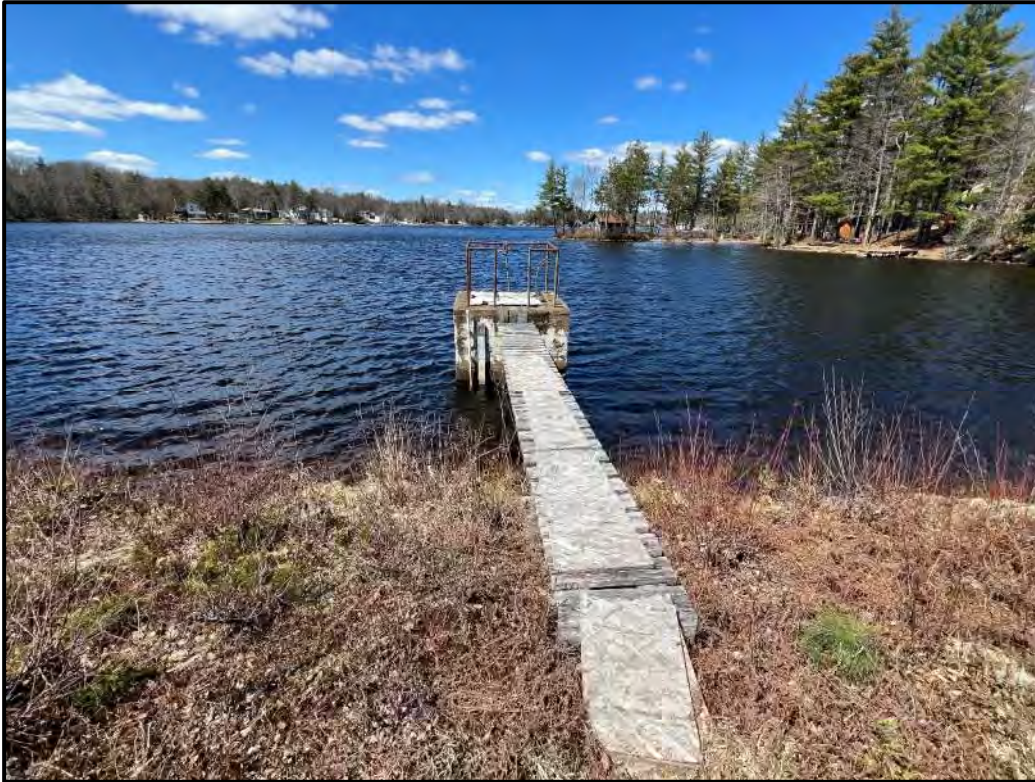
**Photo 1 - Overview of impoundment and low-level outlet structure; note mounted staff gauge and absence of handrails on footbridge**

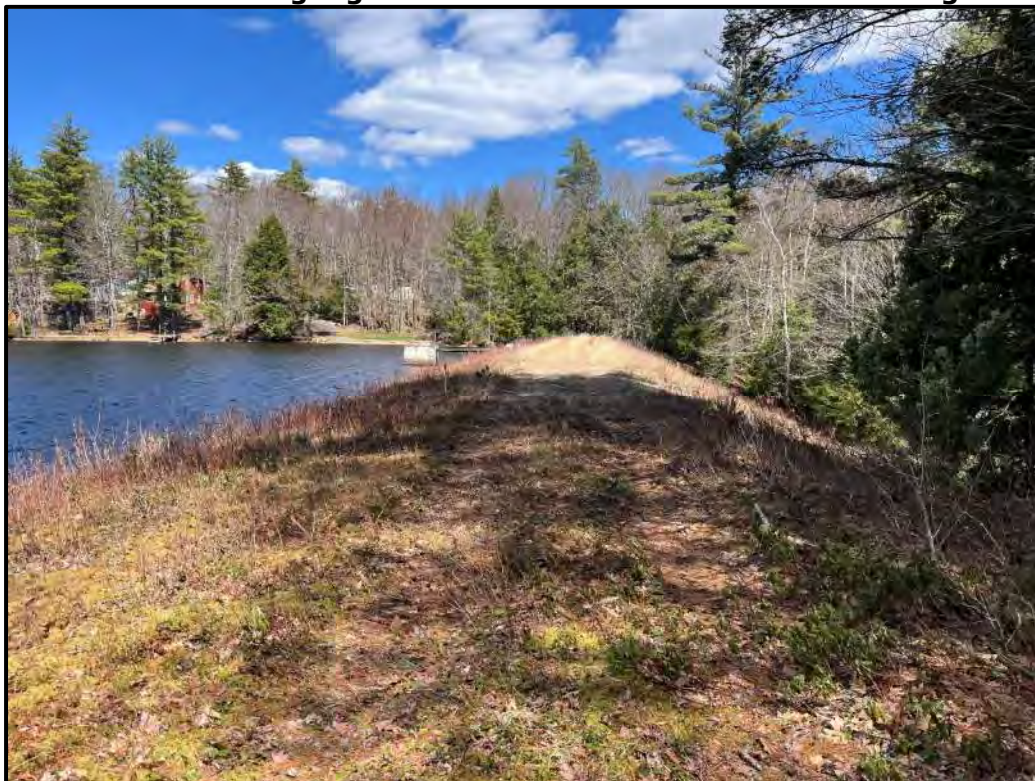
**Photo 2 – Overview of dam crest from right abutment; note trees within 20 feet of embankment and minor rutting (tire tracks)**

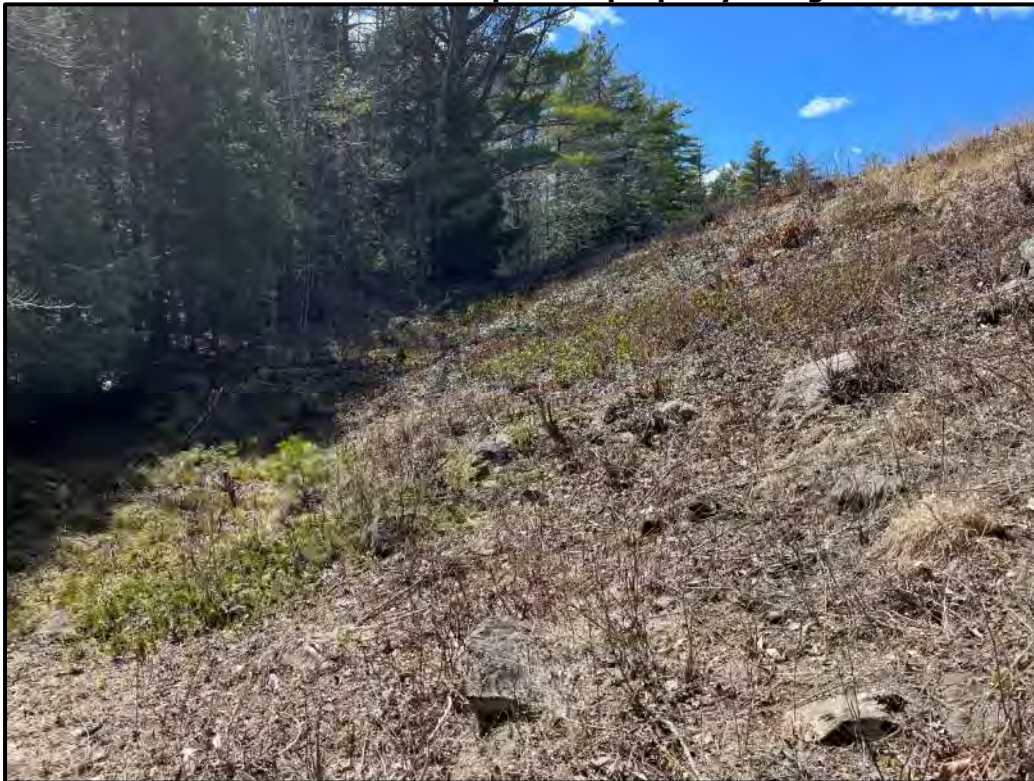
**Photo 4 – Downstream slope near right abutment; note cobbles and areas of bare vegetation on slope and trees within 20 feet of dam**

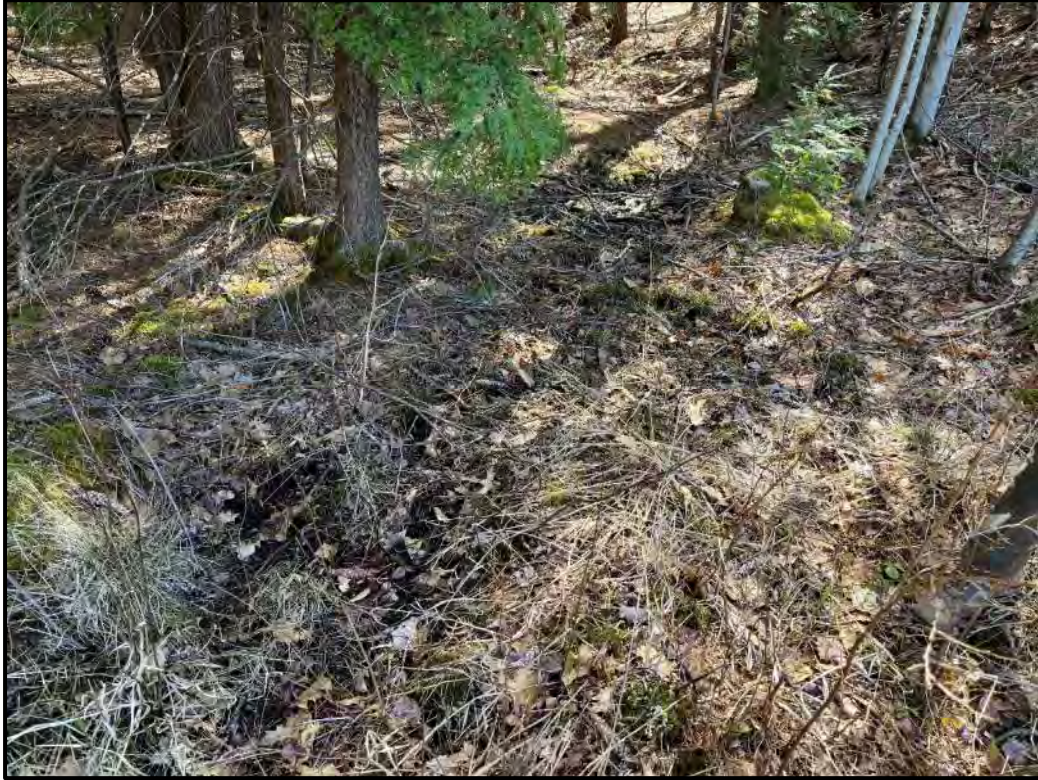
6. A wet area was observed at the right end of the downstream toe.
7. The spillway concrete is spalled, cracked, and efflorescing. Concrete cracking was observed along the flashboards slot of the spillway.

**Photo 5 – Wet area at downstream toe near right abutment**

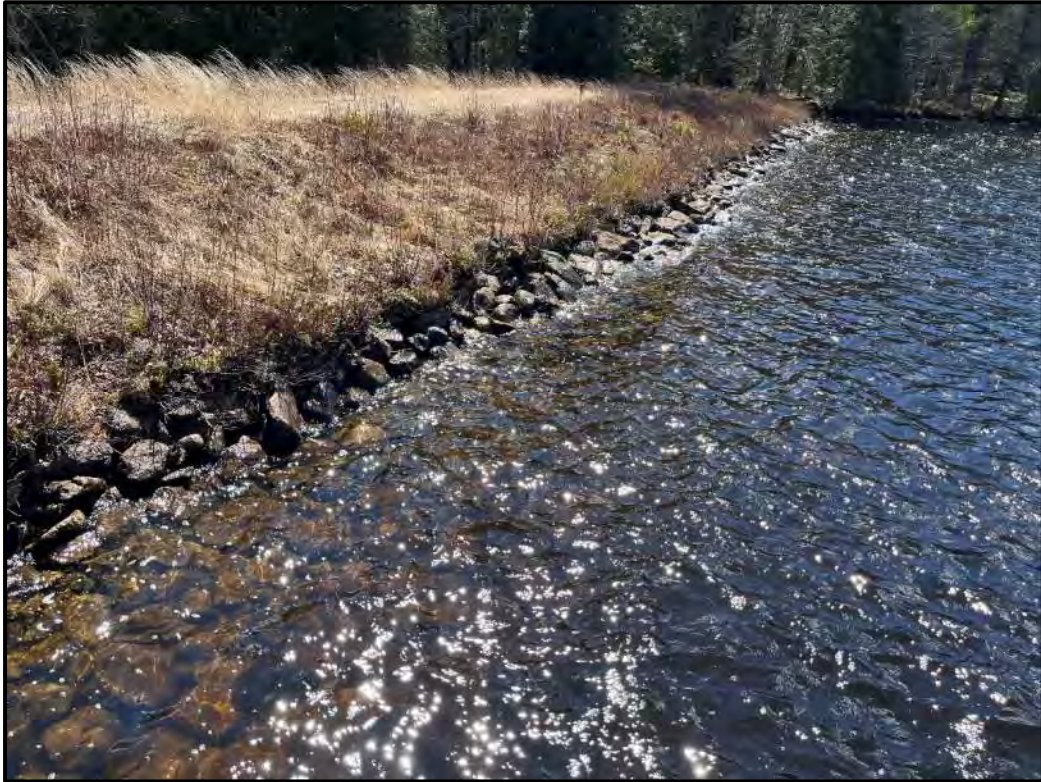
| Previously Identified Deficiency | Resolution or Current Condition |
|---|---|
| The riprap on the upstream slope is small, subangular, displaced in areas, does not extend to the crest, and may not extend very far below the waterline. | Condition remains. |

**Photo 7 – Upstream slope; note small, rounded riprap extending to just above water line**

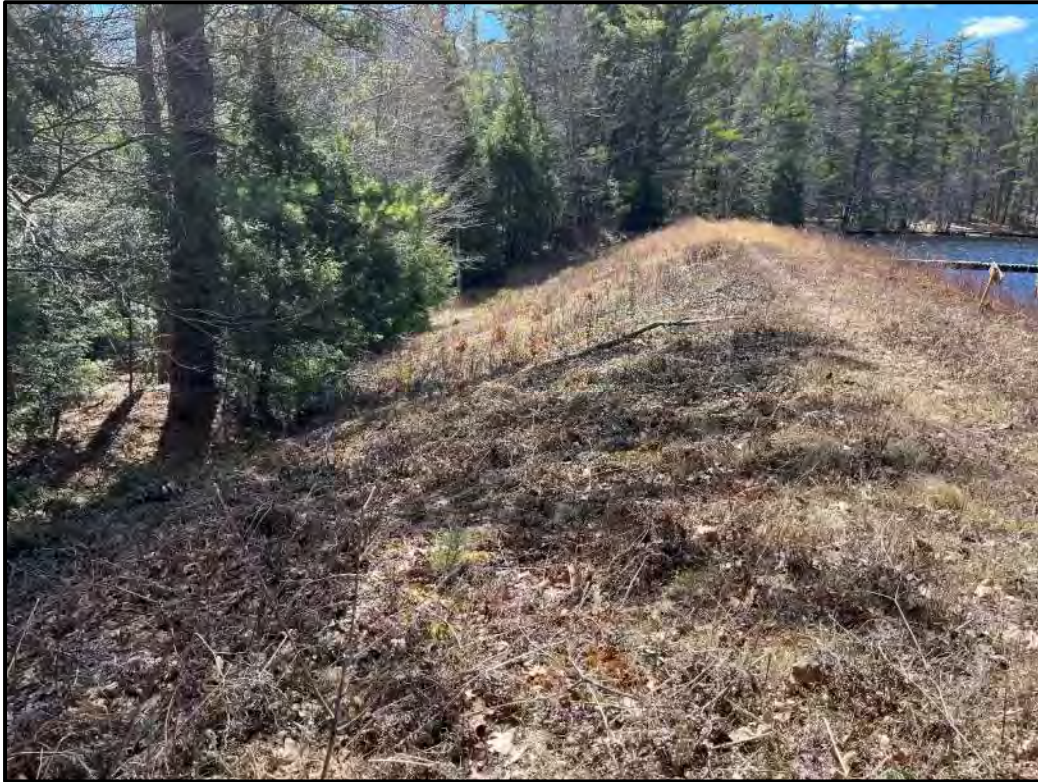
**Photo 9 – Crest and downstream slope from spillway; note trees within 20 feet of the dam**

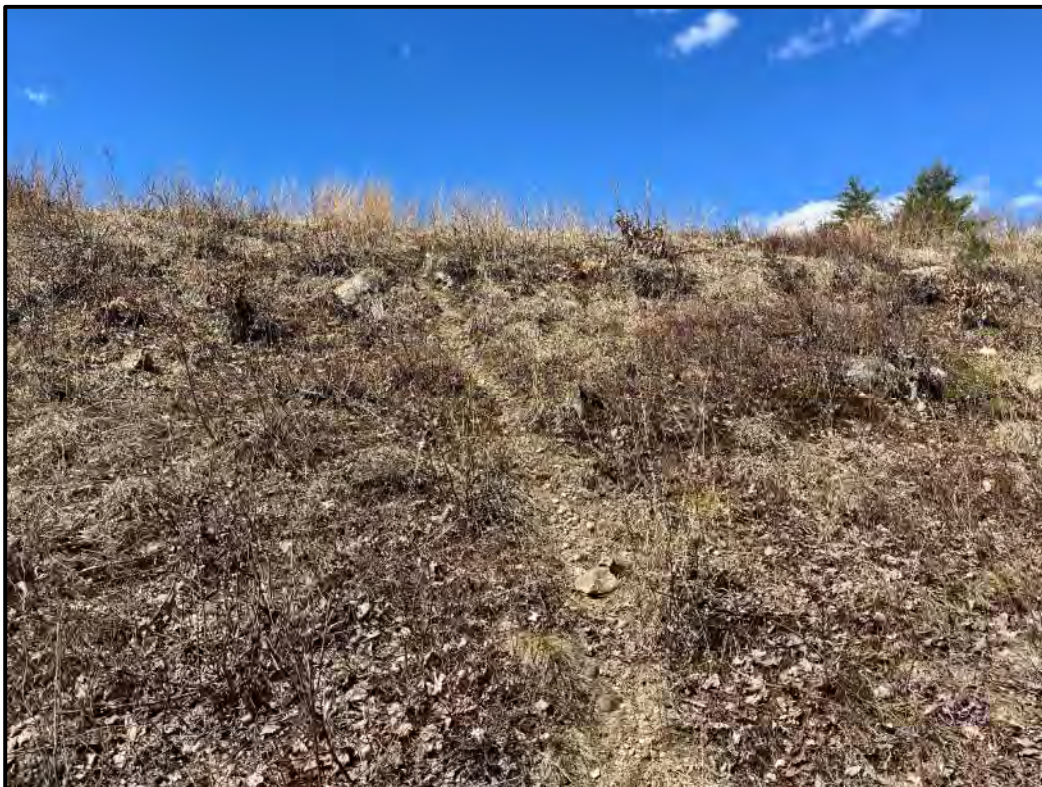
| Previously Identified Deficiency | Resolution or Current Condition |
|---|---|
| A bare game trail was noted from the crest to the toe on the downstream slope. | Condition remains. |

**Photo 10 – Bare game trail on downstream slope**

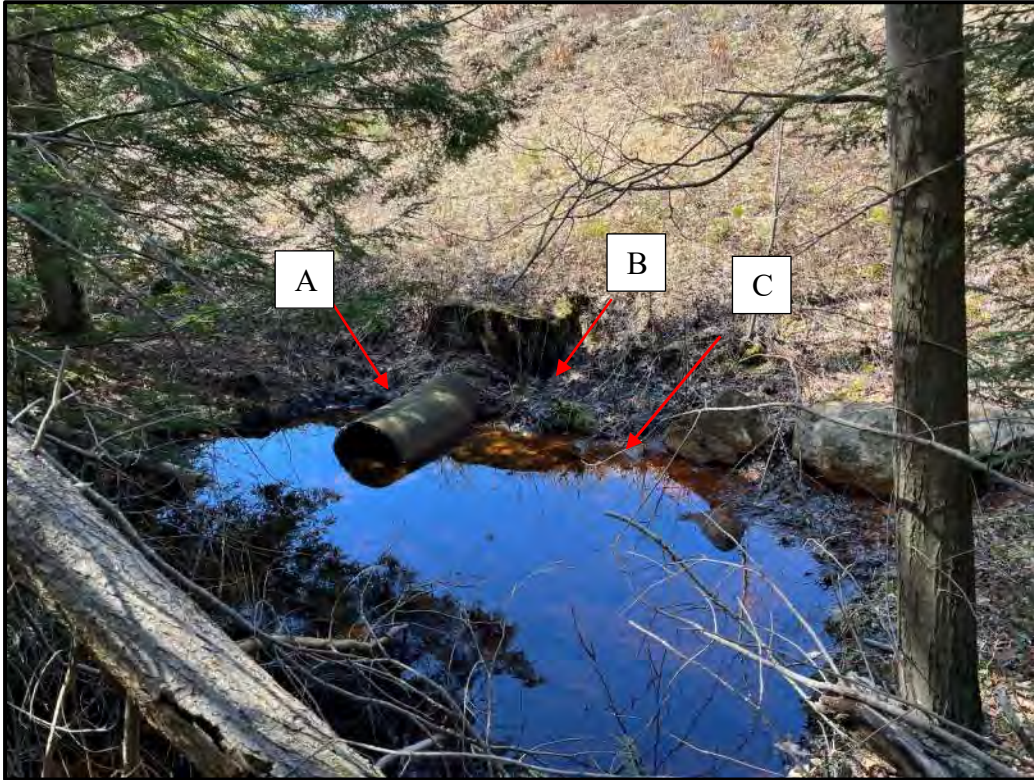
- o The handrail on the outlet structure and gate valve handwheel are rusted.
- o The downstream end of the outlet pipe projects from the embankment approximately five feet. There is a circumferential crack approximately 2 feet from the end.

- o Downstream water filled the downstream pipe about halfway up.
- o The concrete near the downstream end of the outlet pipe was observed to be spalled, undermined and potentially displaced.

13. Seepage with iron staining is present at the downstream toe near the low-level outlet pipe.

**Photo 11 – Outlet structure discharge conduit; note that outlet has a crack “A” (see Photo 25), concrete is undermined and displaced “B”, and seepage with iron staining “C”**

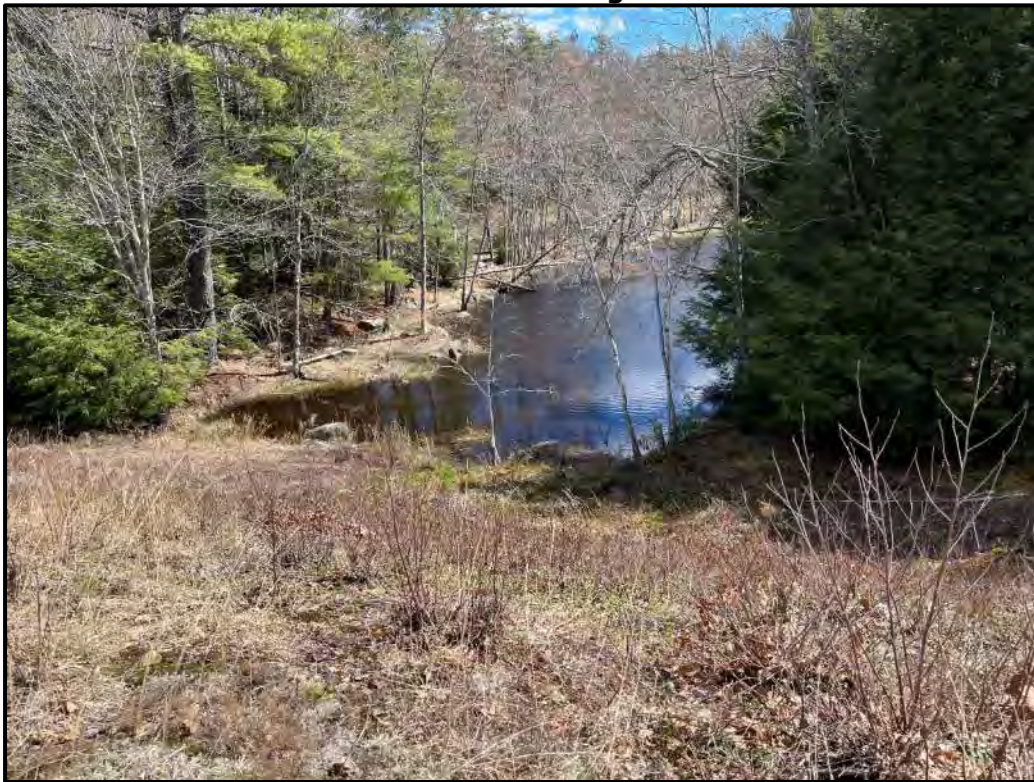
- o Beaver debris in the downstream area creates a tailwater condition that submerges the lower portion of the low-level outlet conduit and the downstream toe of the dam's maximum section.

**Photo 12 – Overview of tailwater pool at toe of downstream slope**

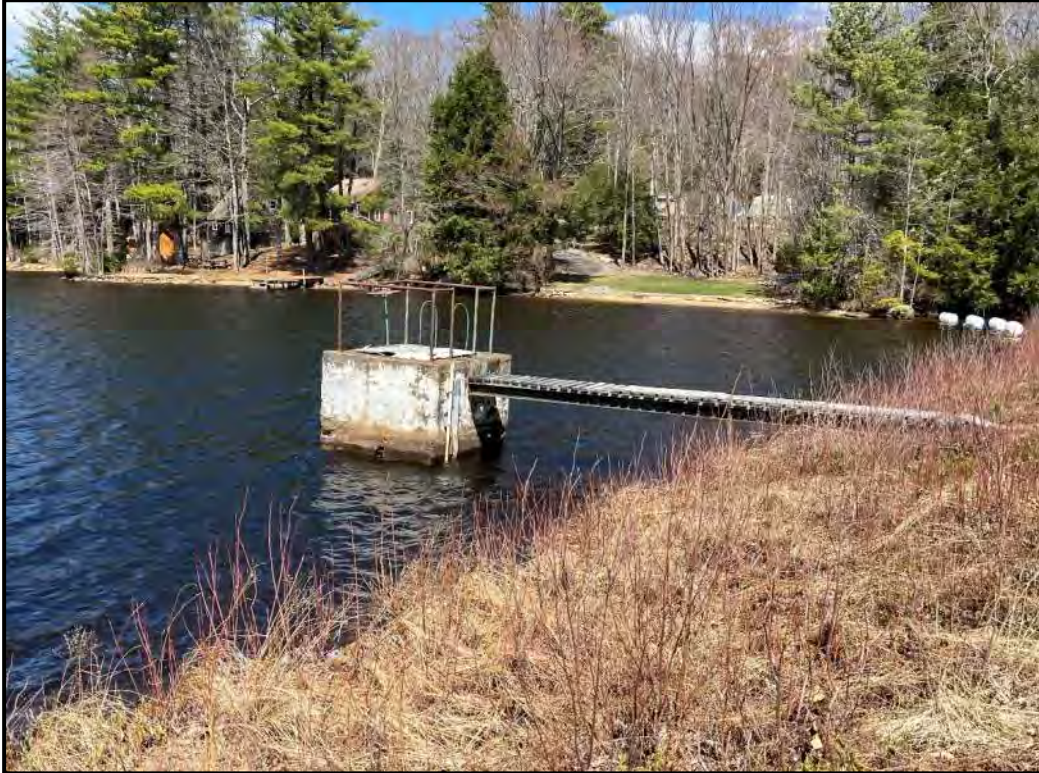
**Photo 13 – Right side of intake structure; note spalls and concrete erosion; see Photo 26 from Oct 2023 with lower reservoir level**

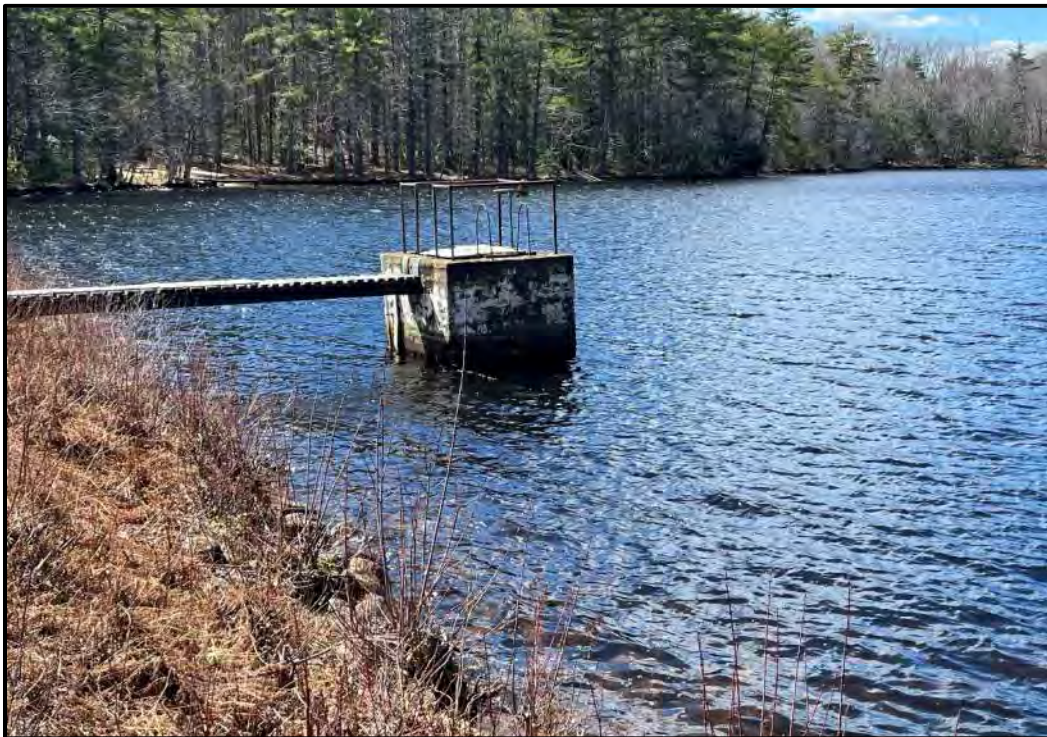
**Photo 14 – Left side of intake structure; note spalls and concrete erosion; see Photo 27 from Oct 2023 with lower reservoir level**

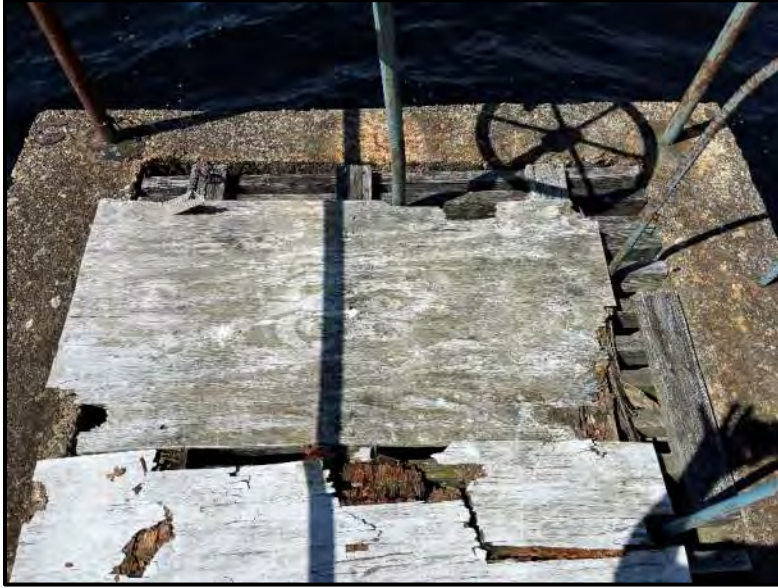
- o The grating on the outlet structure and the bridge to the outlet structure are wood and not well constructed. Plywood boards cover the grating on the outlet structure and are deteriorating and were difficult to safely remove. There are no handrails on the bridge. The interior of the structure was partially obscured due to the plywood boards and wooden grate during this inspection. The following observations were made during previous inspections:

**Photo 15 – Top of low-level intake structure. Wood grating and deteriorating plywood boards partially obscured interior of structure**

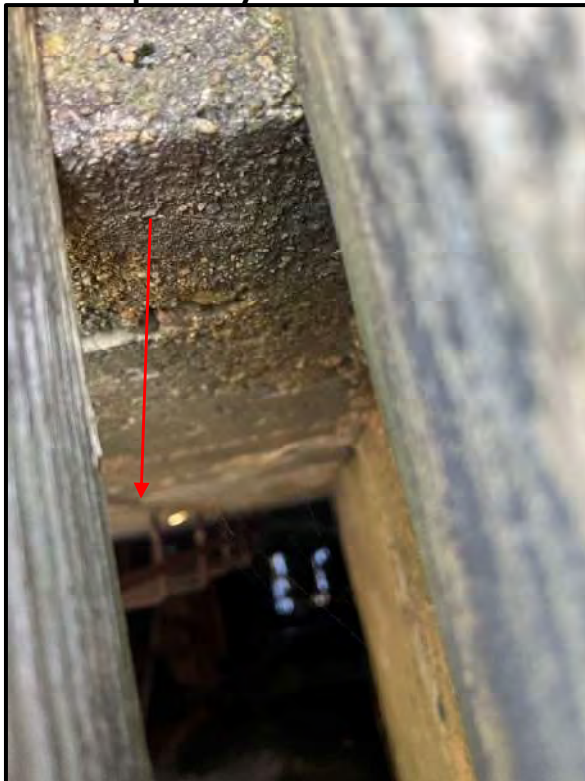
- The gate stem is bent, and the upper stem bracket appears to be broken.
- Minor debris are present inside the outlet structure.
- The ladder within the intake structure is constructed of bent rebar and tires. It may not be safe to use.

**Photo 16 – Interior of the low-level outlet's intake structure; note ladder constructed of bent rebar**

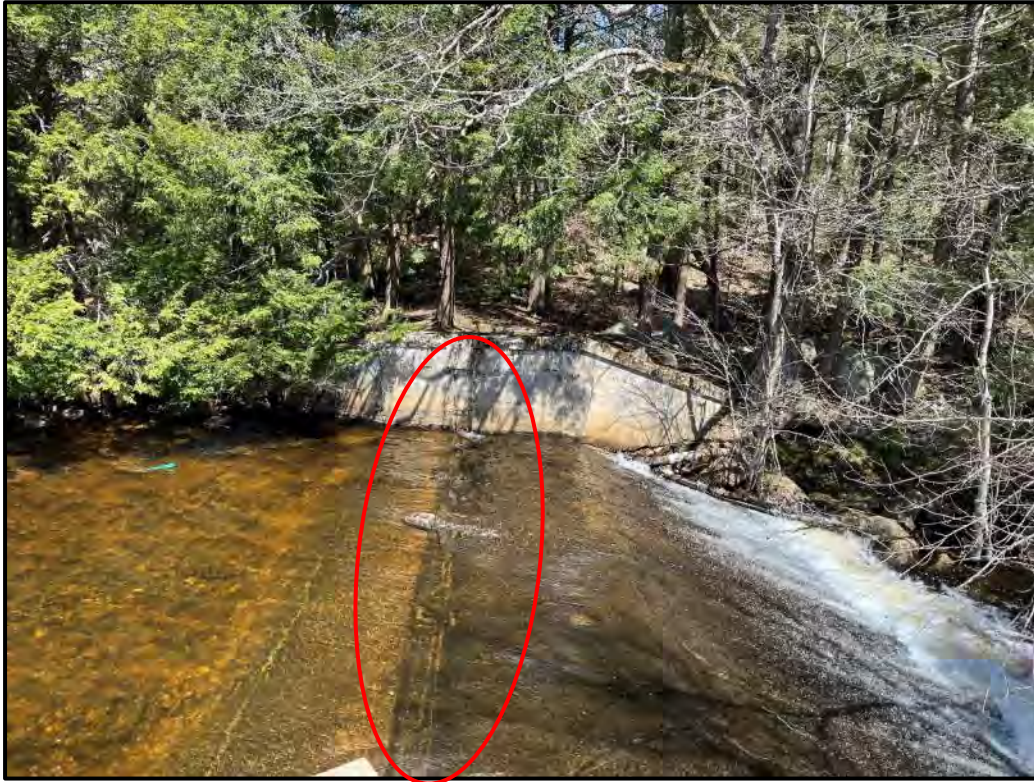
**Photo 17 – Spillway and left training wall; note trees on downstream left training wall and flashboard/support slots**

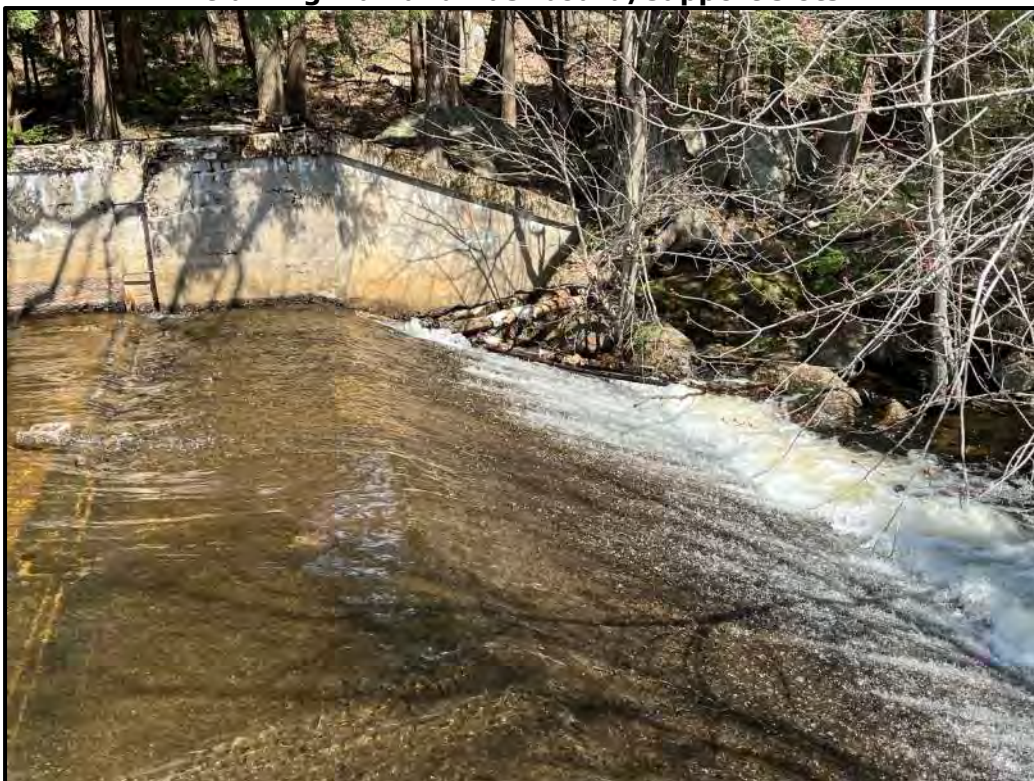
**Photo 18 – Left spillway training wall; note cracking, efflorescence, and trees growing adjacent to the wall**

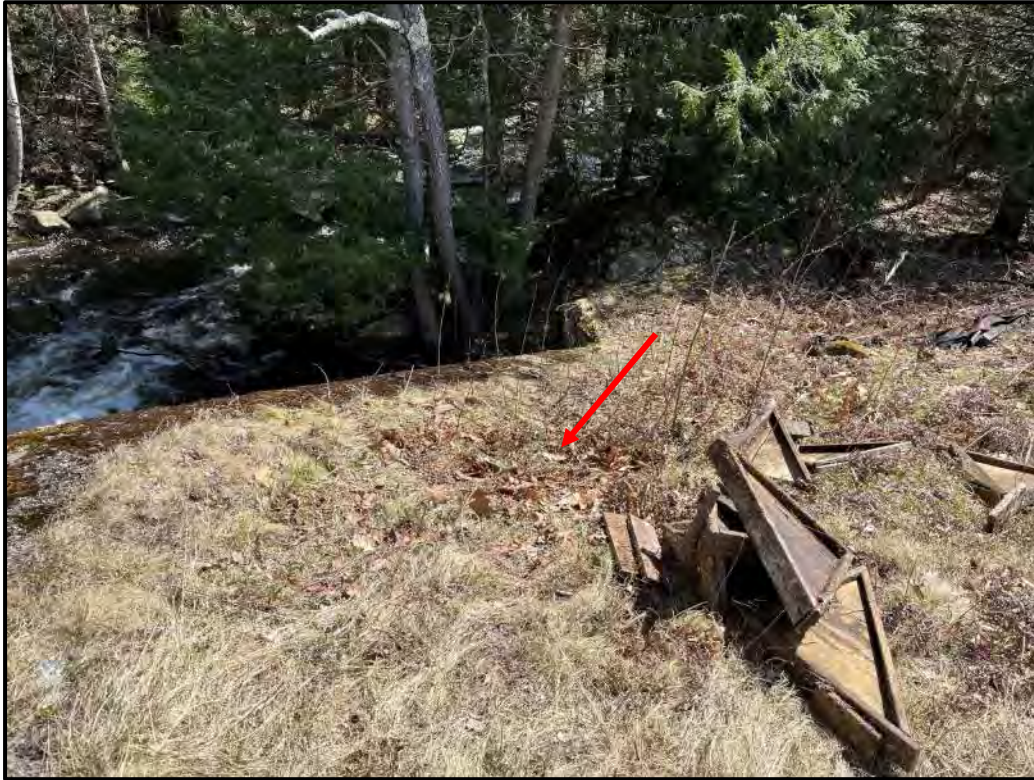
8. A depression was observed behind the spillway right training wall.
9. The spillway weir may be undermined at the downstream end.
10. The low-level intake structure is deteriorating; with spalled, eroded, and cracked concrete on the exterior; cracks on the interior; bent and rusting handrails; a poorly made and deteriorating internal ladder; deteriorating grate over the top; and an inadequate wooden bridge with no handrails.

**Photo 19 – Downstream embankment behind right spillway training wall; note depression behind wall**

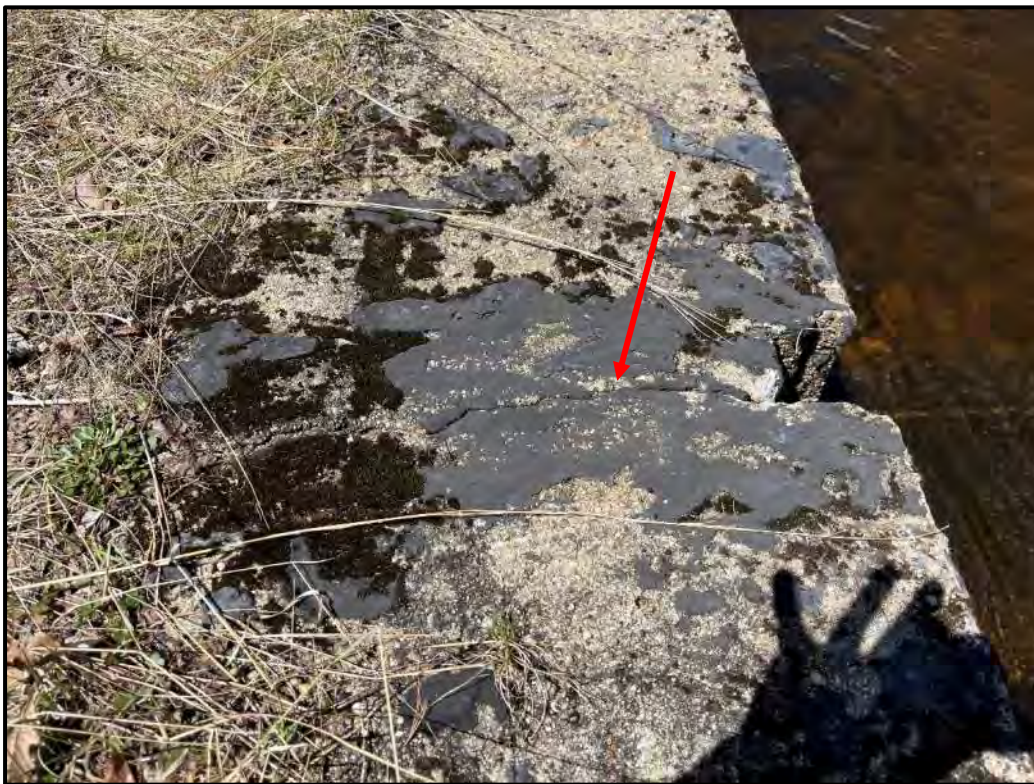
**Photo 20 – Transverse crack in right training wall at the flashboard slot**

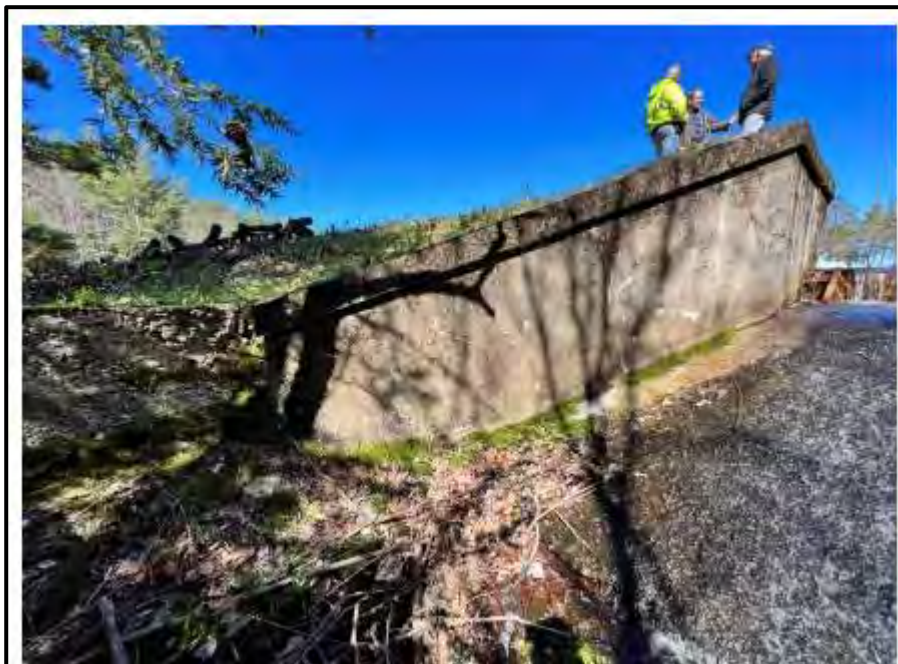
**Photo 22 – Photo from previous Tighe & Bond inspection, taken on 5/11/22, showing right training wall with minor cracking and efflorescence**

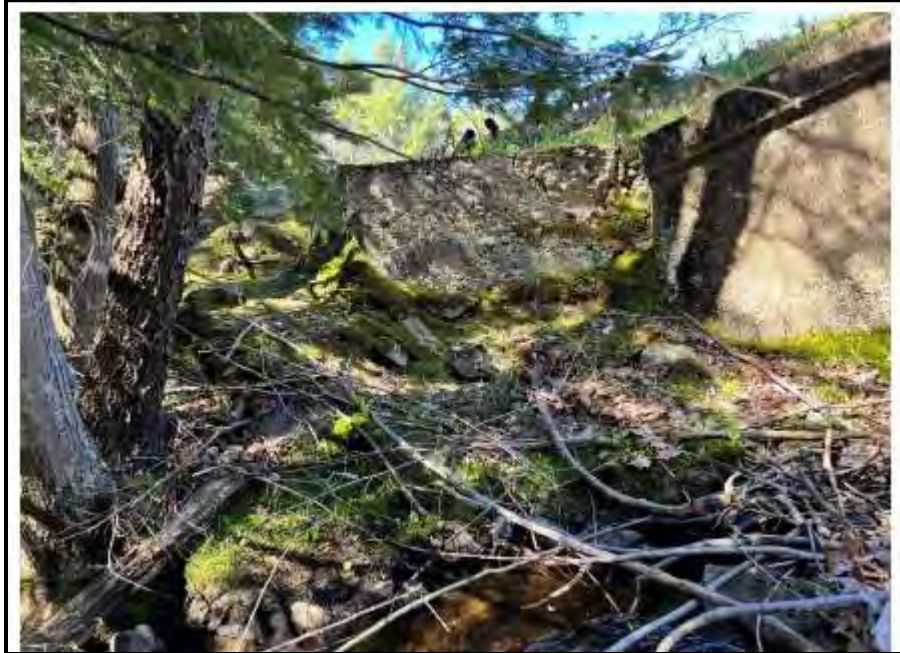
**Photo 23 – Photo from previous Tighe & Bond inspection, taken on 5/11/22 showing downstream section of right training wall with concrete deterioration and vegetation near the wall**

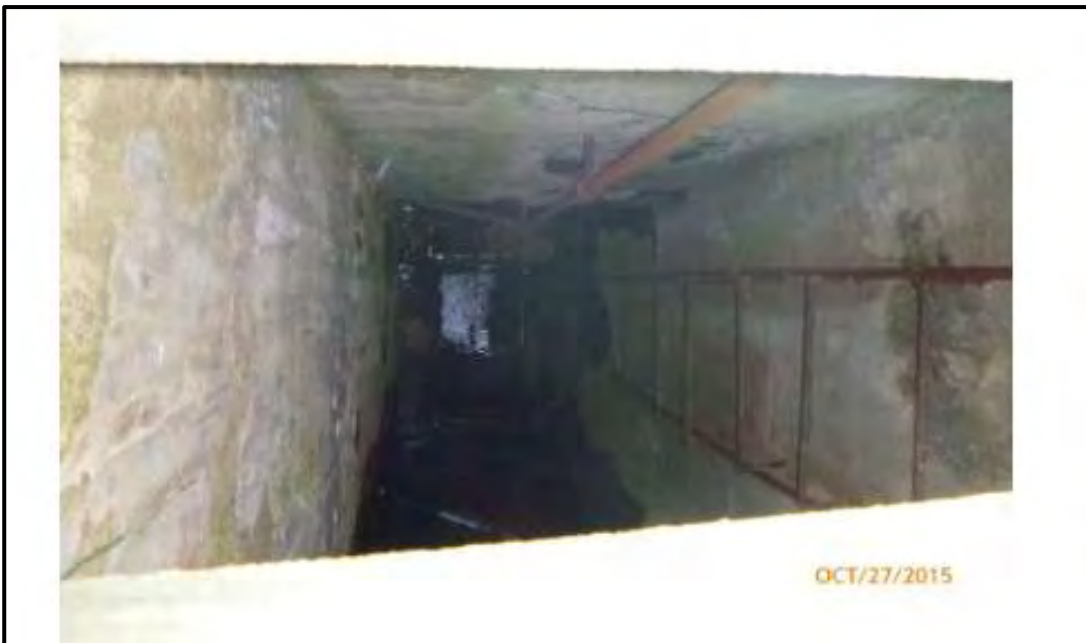
- Cracking has been observed in the interior of the structure, and leakage was observed entering the structure.
- The gate valve appeared to be leaking. It is not known whether the gate is operable.

**Photo 24 – Photo from previous Tighe & Bond inspection, taken on 10/27/15 showing interior of low-level outlet's intake structure and gate valve; note minor leakage, ladder constructed of rebar, gate stem appears bent**

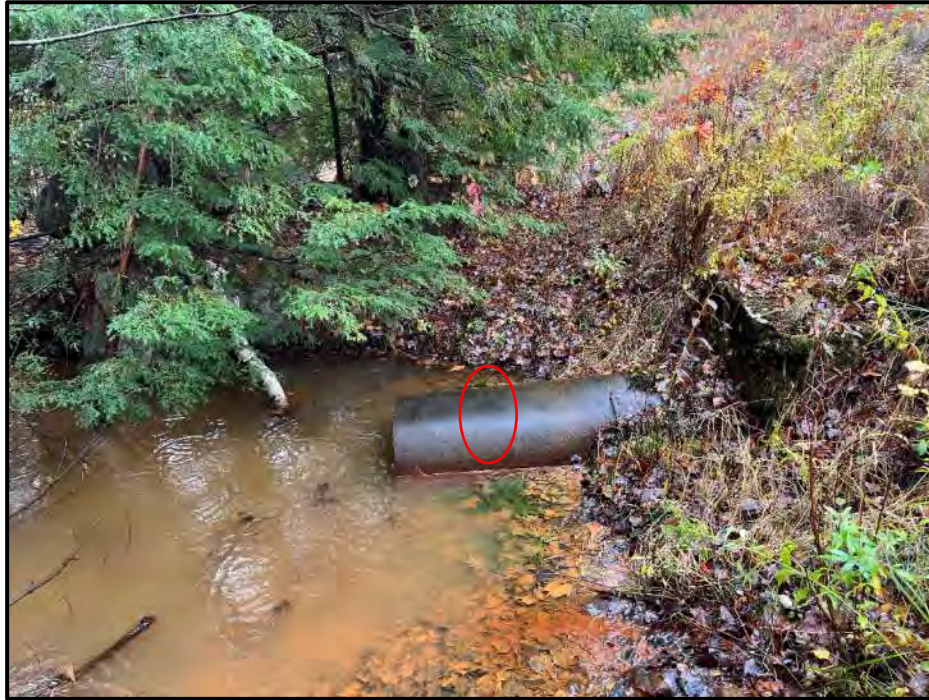
**Photo 25 – Outlet structure discharge conduit with crack (Photo taken by Tighe and Bond on 10-30-23)**

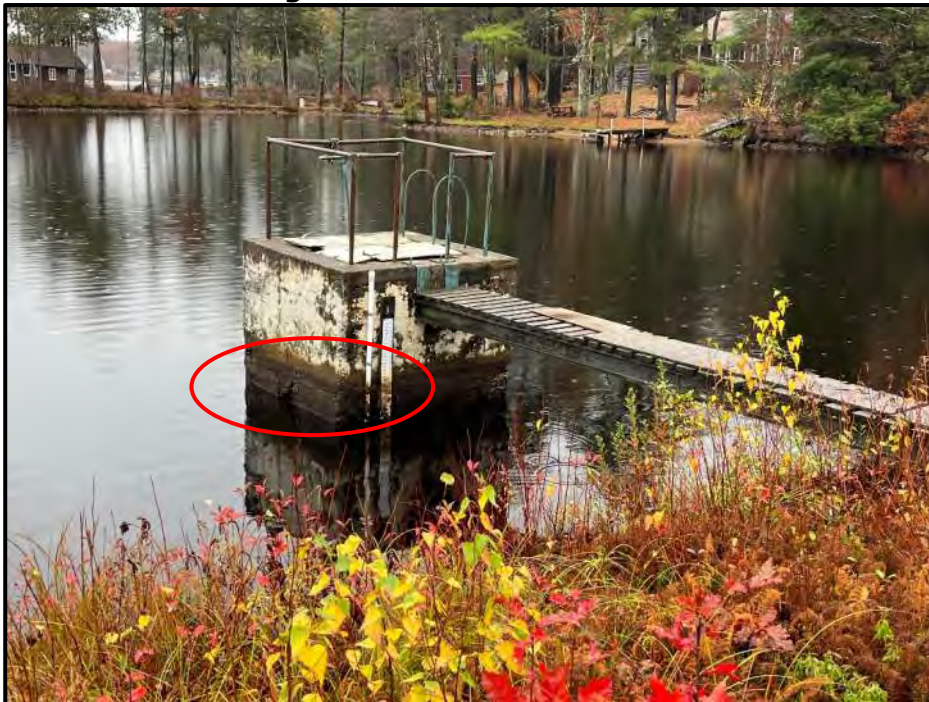
**Photo 26 – Right side of intake structure; note spalls and concrete erosion, especially near water line (Photo taken by Tighe and Bond on 10-30-23)**

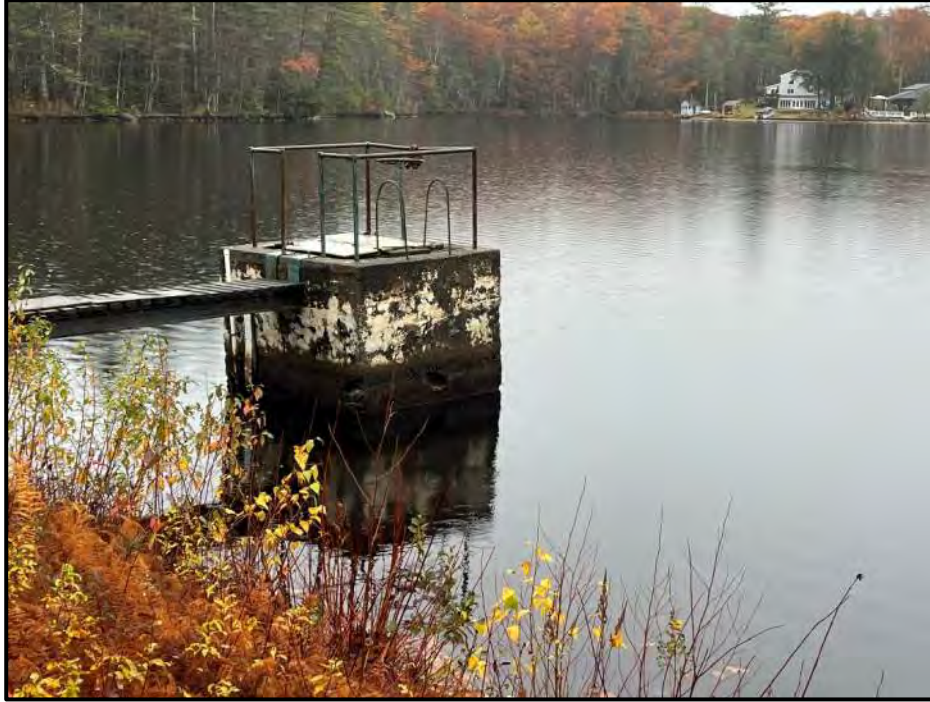
**Photo 27 – Left side of intake structure; note spalls and concrete erosion, especially near water line (Photo taken by Tighe and Bond on 10-30-23)**
